## [»» Catastrophic Forks Failure](#)

### Catastrophic Forks Failure

Photos from my crash in the Yukon (clear day, bit windy, smooth pavement, and was riding a 2002 F650GS.

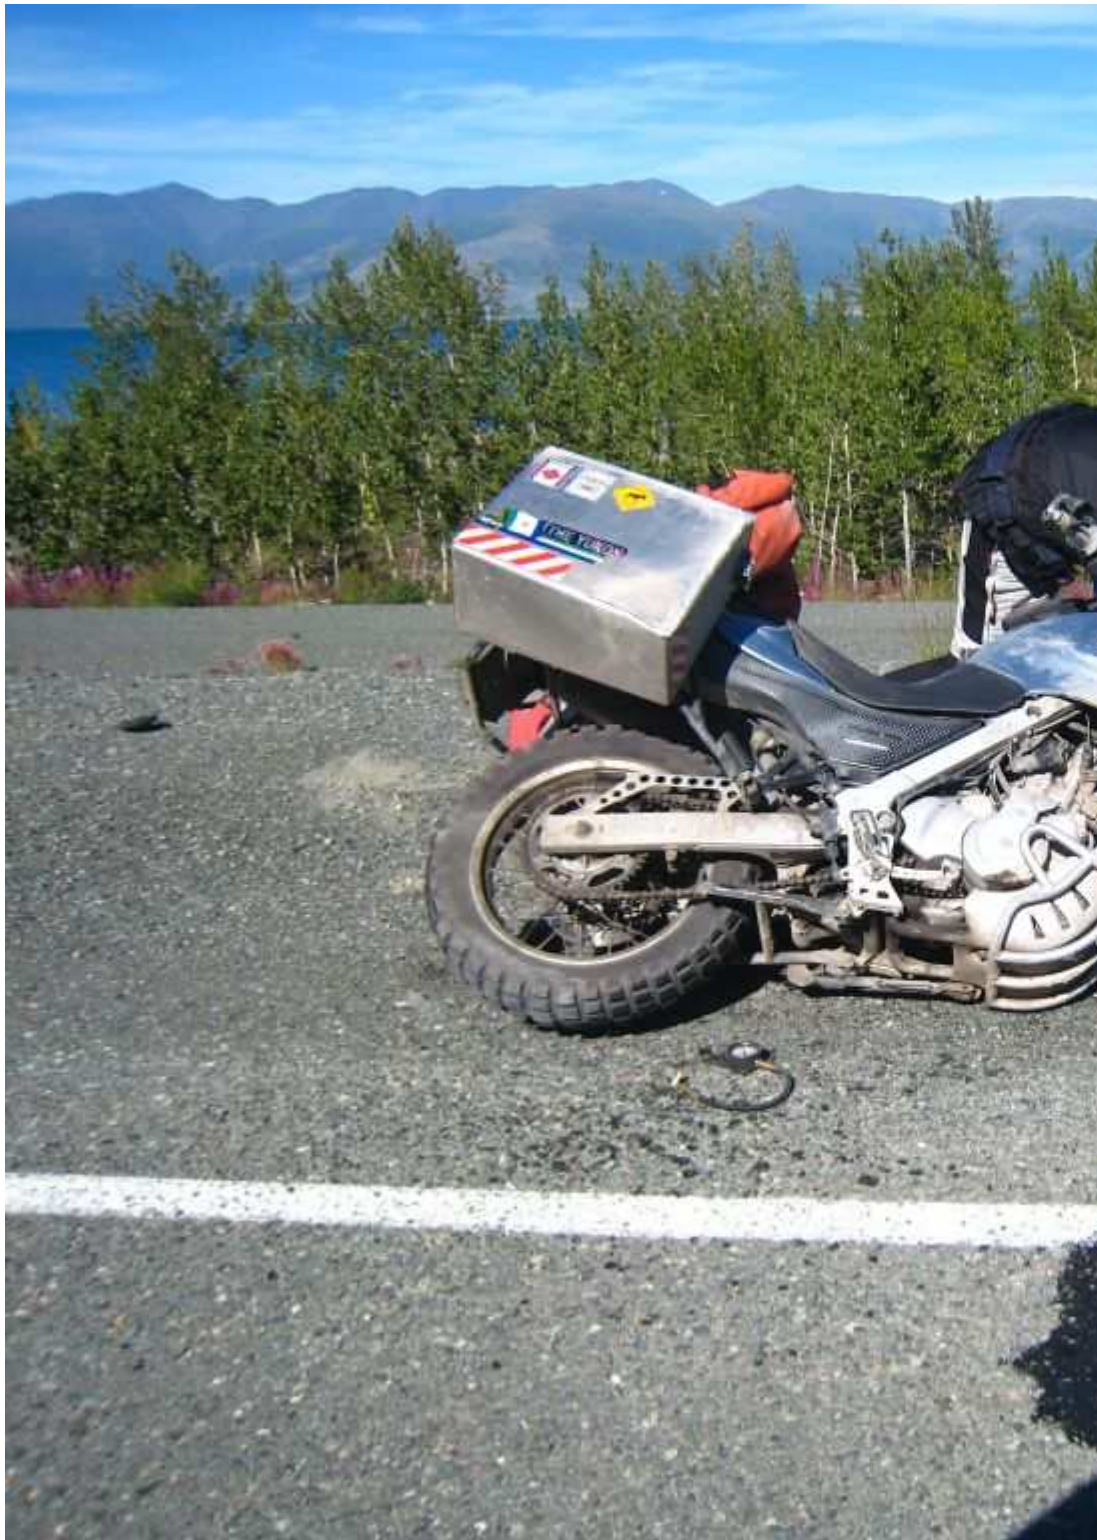
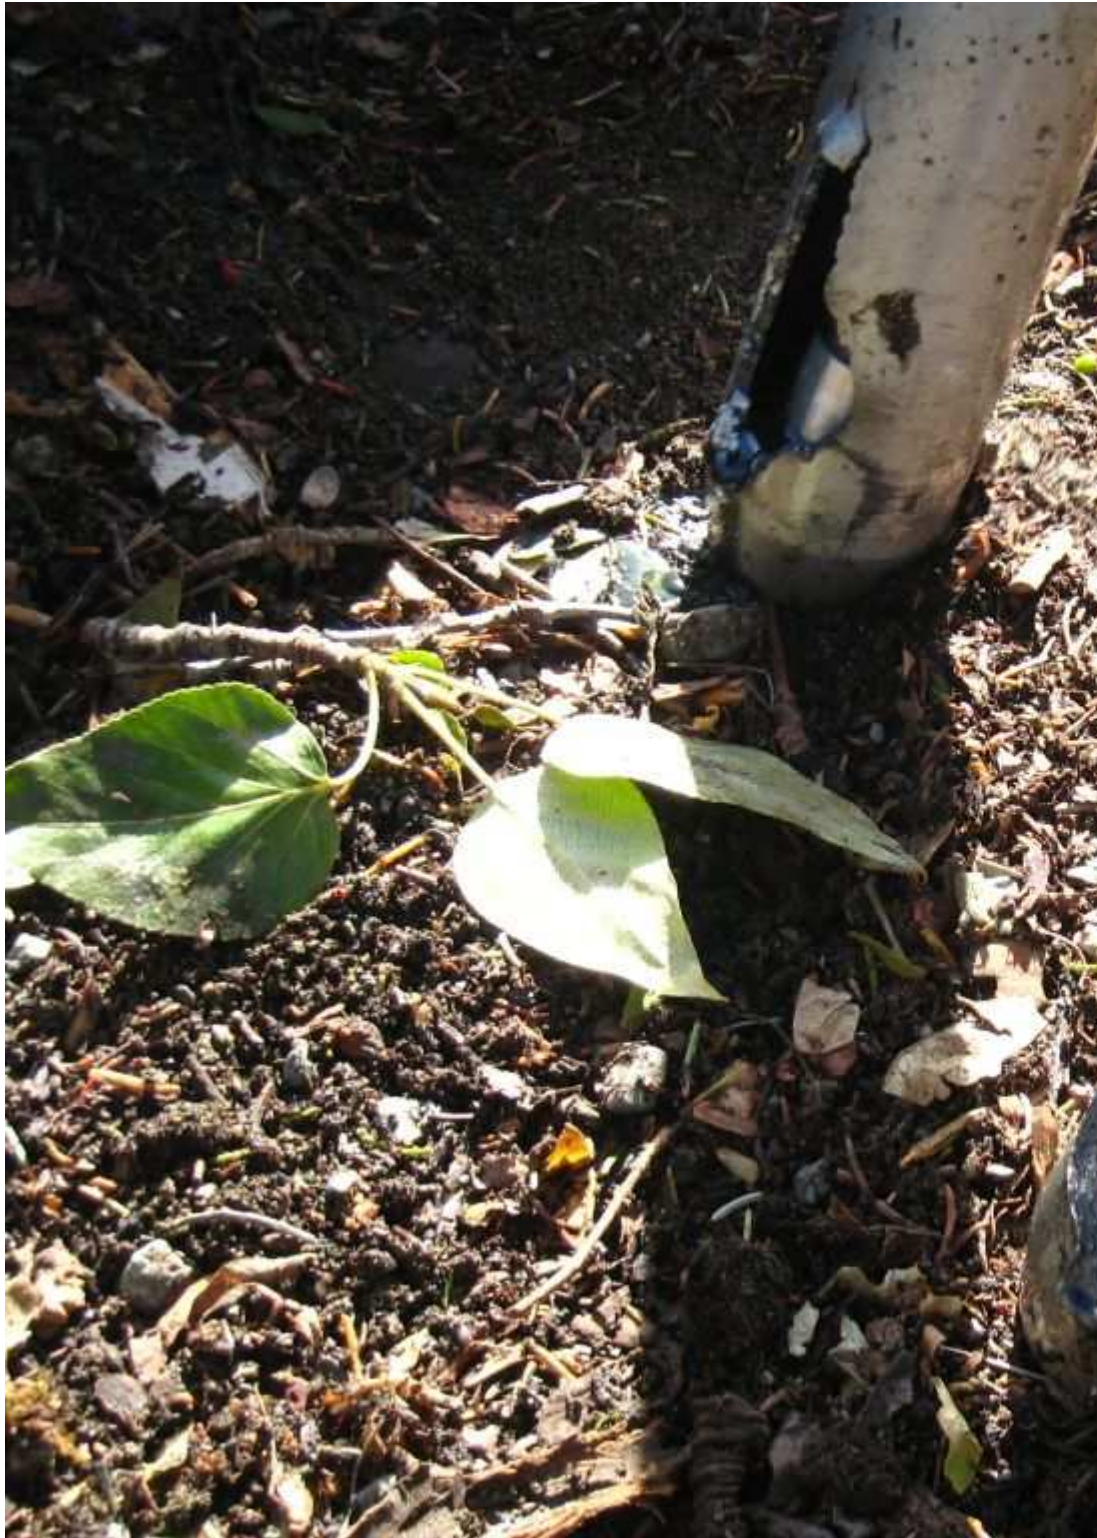
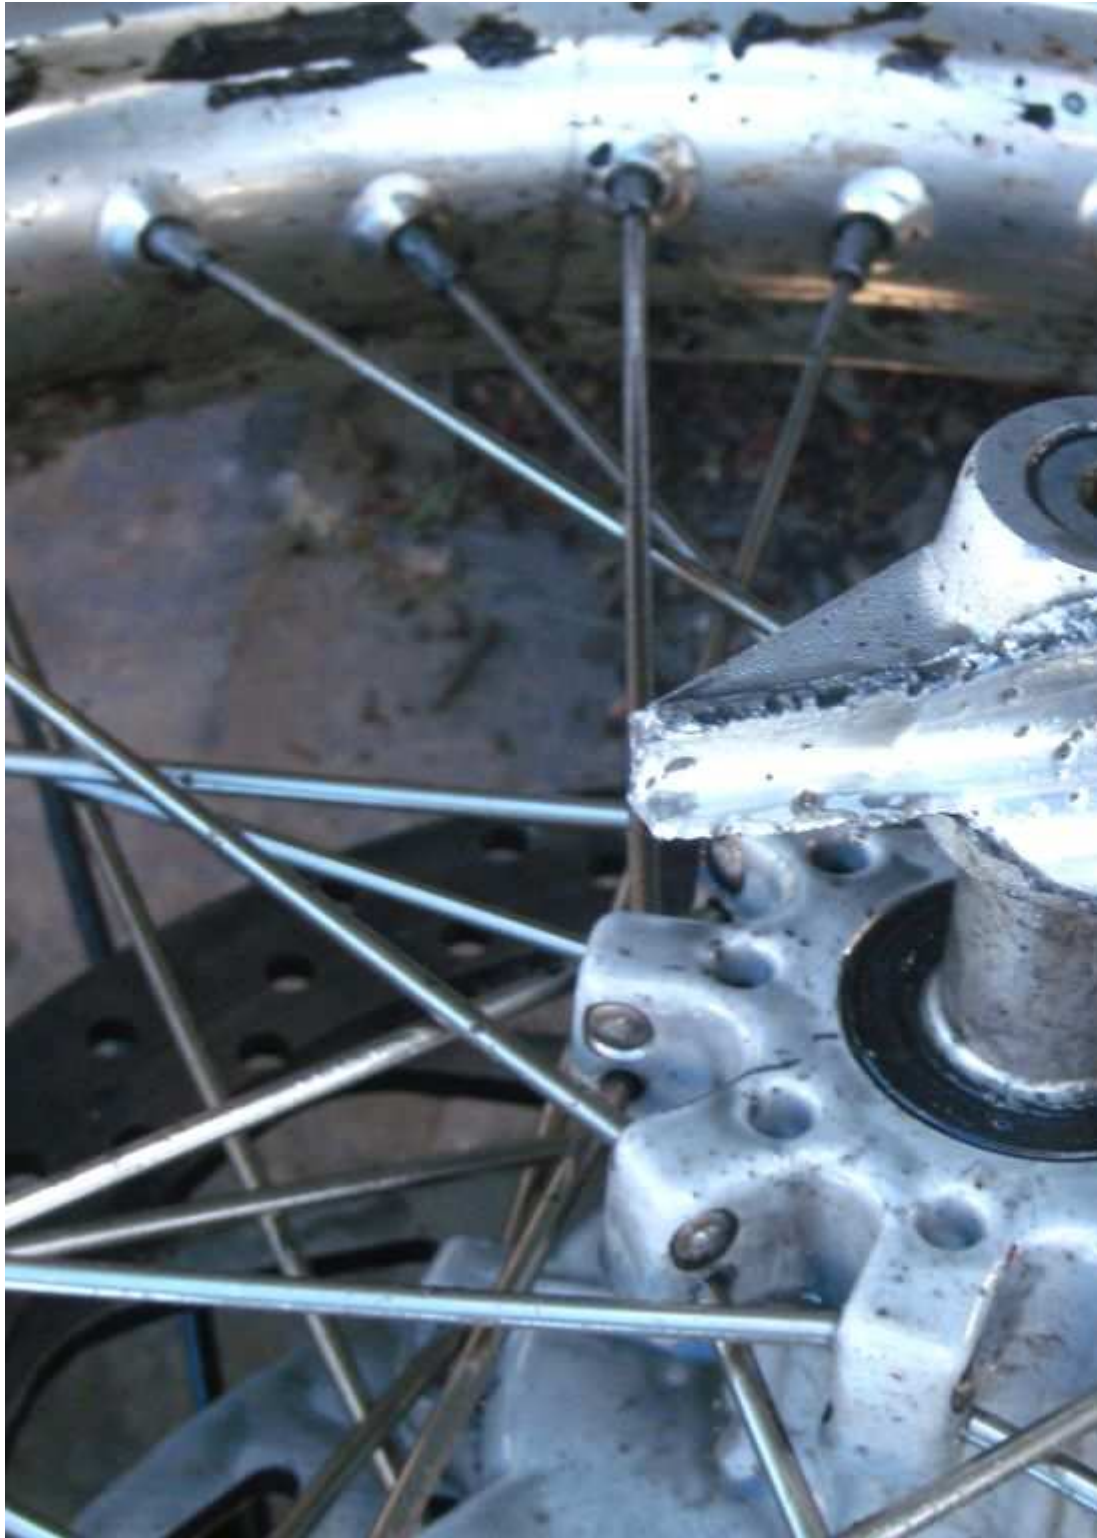
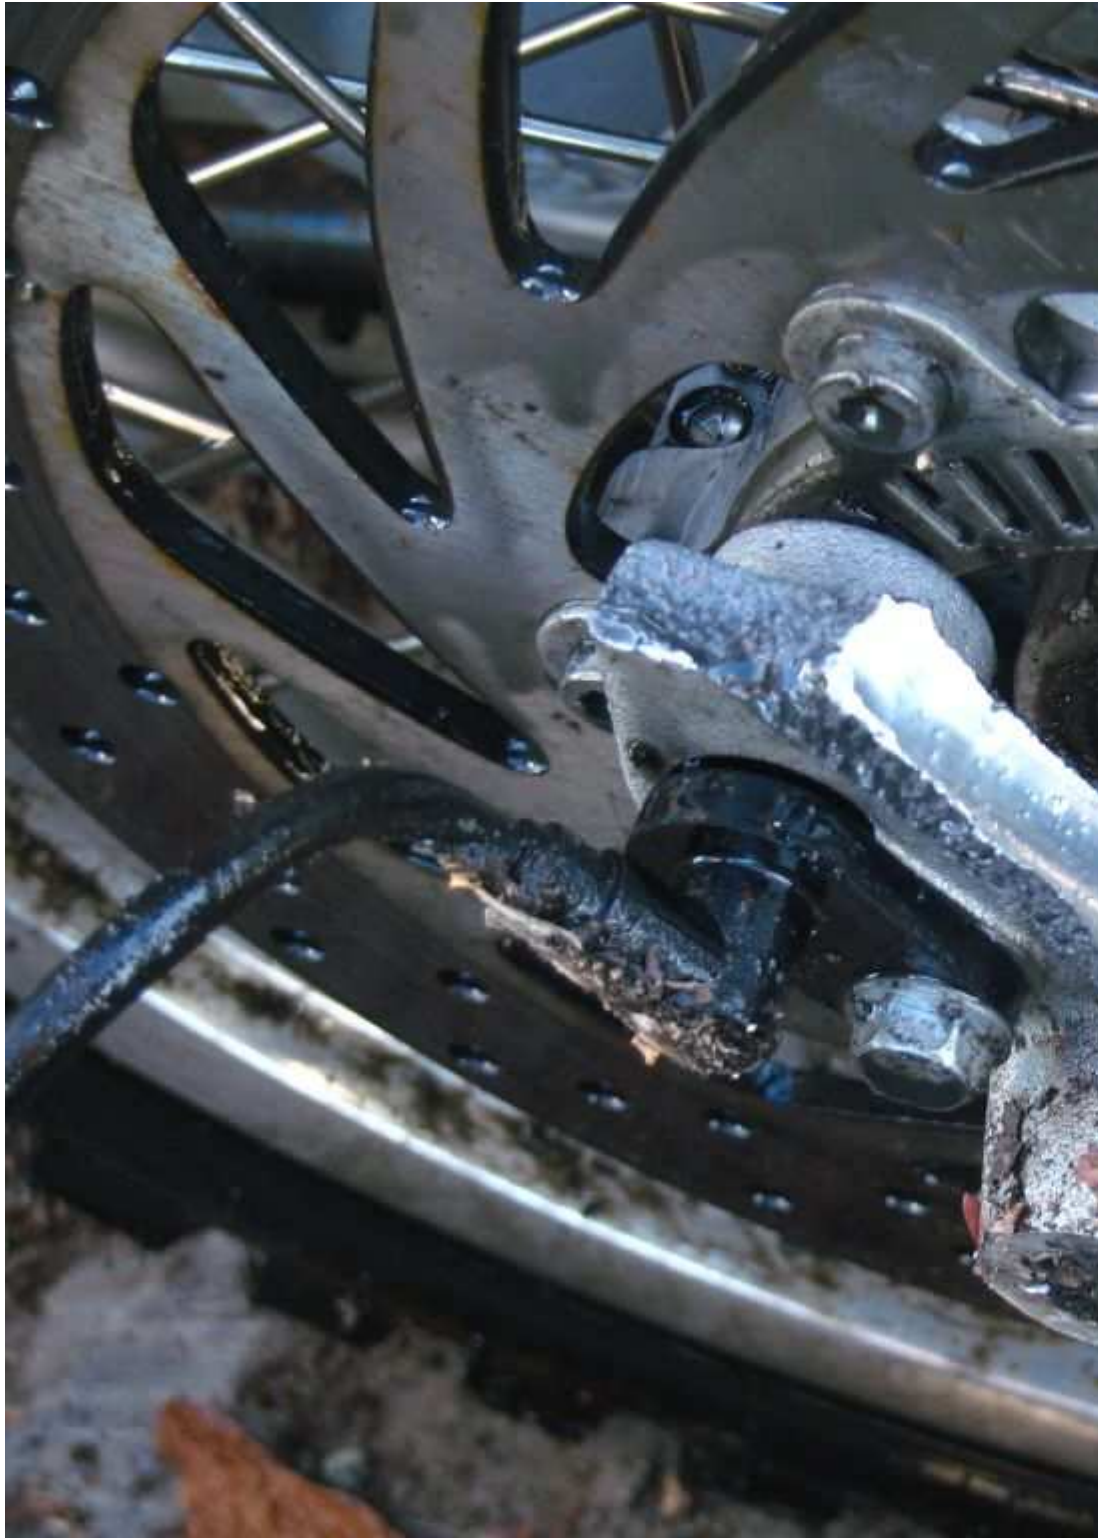
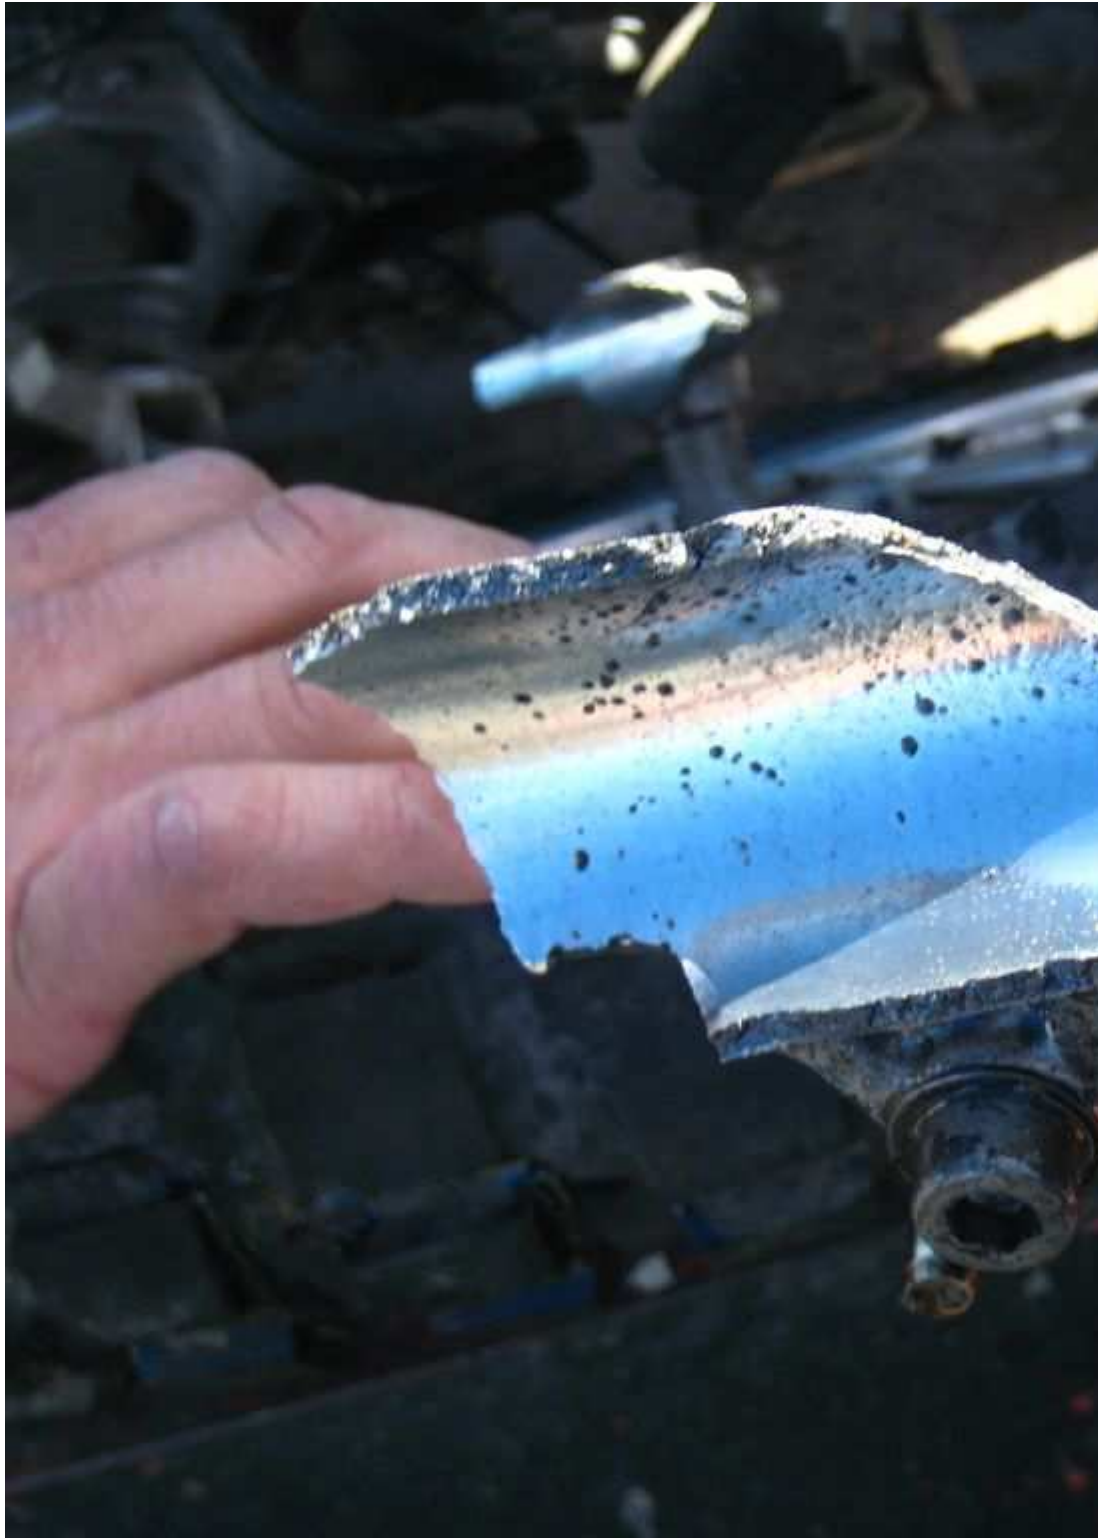
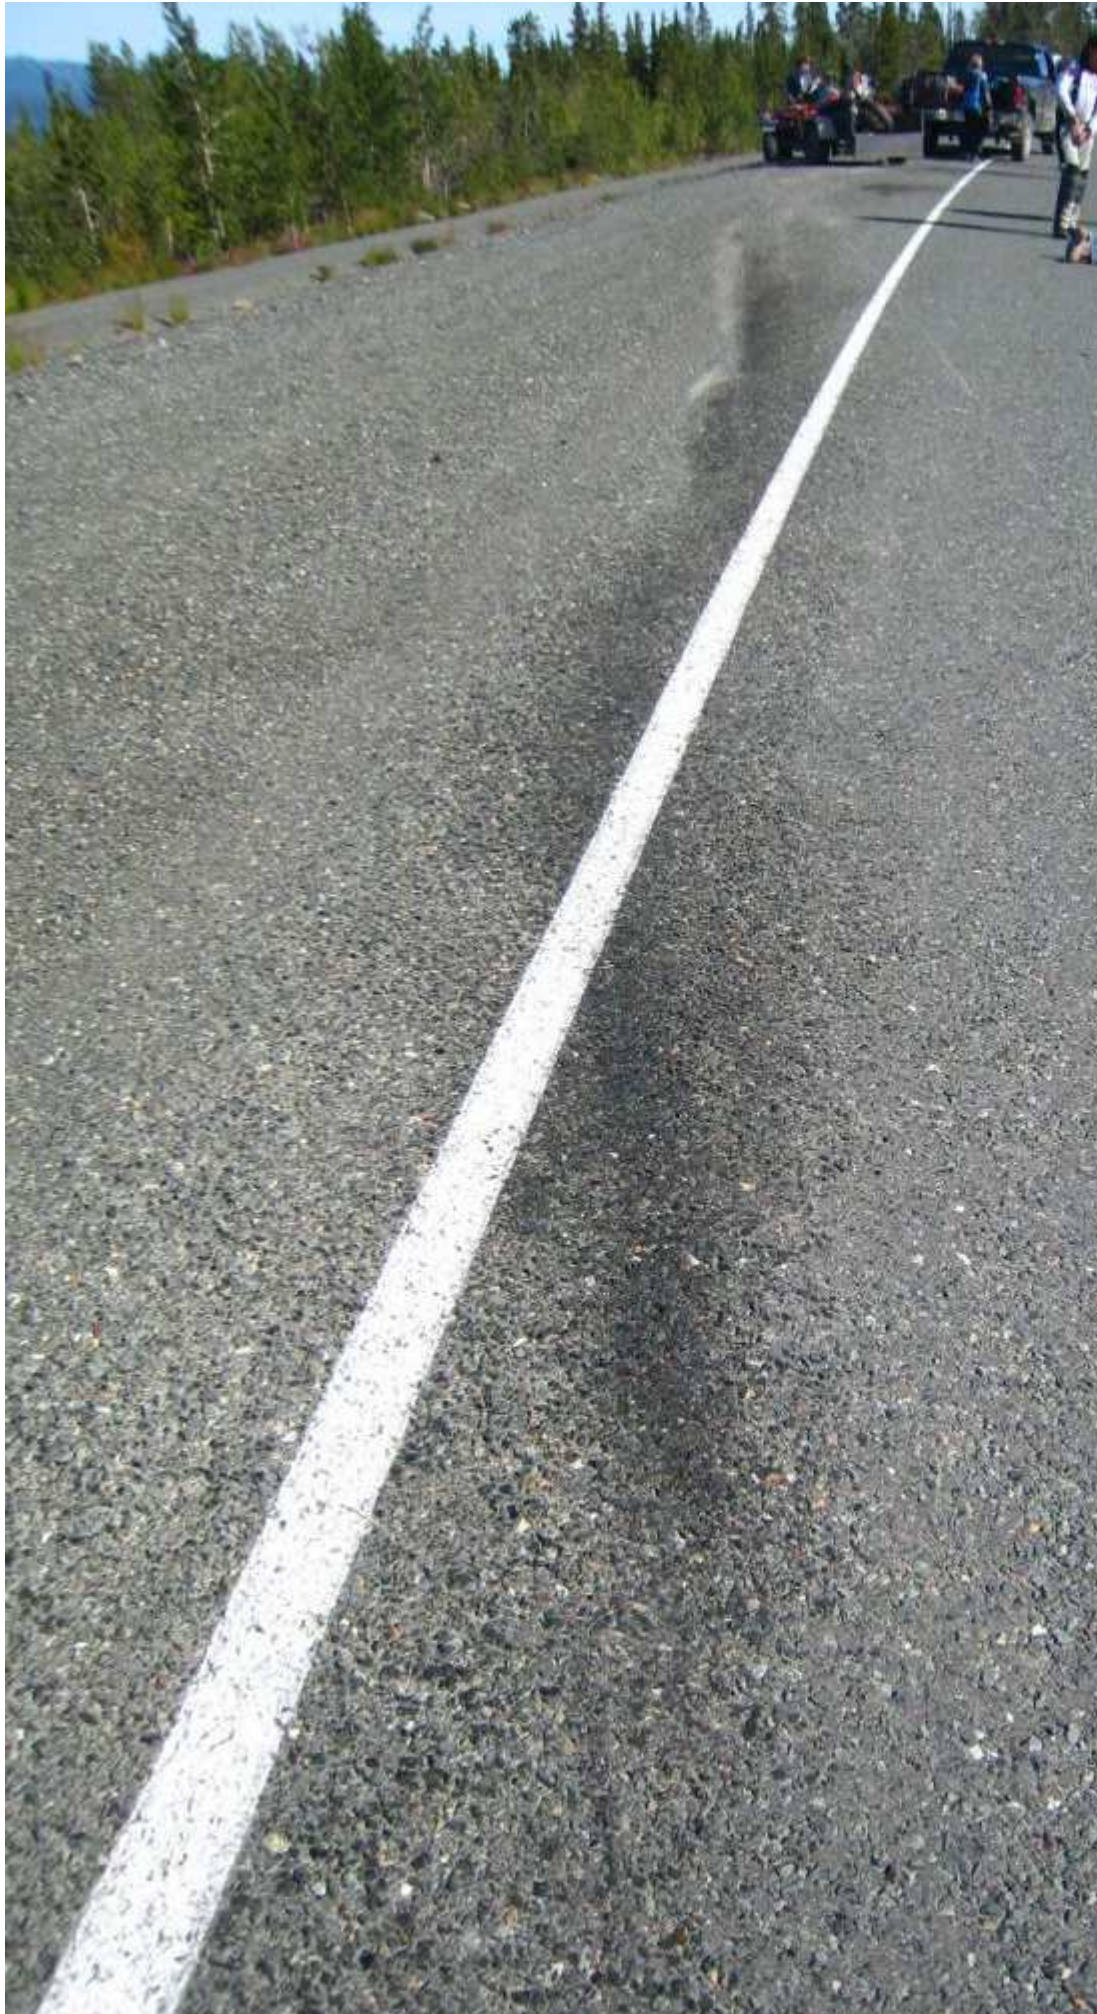
I have never seen a break on a bike like this, but to me it is a failure within the Heat Affected Zone while the forks were made. Aluminium gets brittle when welded and should be pre heated and post heated in these critical area's. I don't think that that happened here. 🙄 I am also looking at the massive pitting inside the fork material and this could also be a factor in the failure.

Not sure there are any grounds for litigation. Looking at the pictures shows severe pitting, and corrosion on the rim, bolt head and the aluminum. This is not normal, and would indicate some long exposure to caustic substances. Hardly a "defect" IMHO.

Yeah, but the pitting looks like it's on the inner diameter of the fork's tube--not something that a user would normally have access to.

I have not clue which it really is, but I wonder if it is pitting or maybe *porosity* in the casting?

Hey Jim. I agree that it looks more like porosity than pitting. However, I don't know how much porosity, if any, is allowed by the applicable standards. I would assume that very little porosity is allowed for such a high-stress member. I would also be curious to know what type of non-destructive testing the manufacturer does on these things before they leave the factory.

Jim ... I agree it looks like porosity (arm-chair-qback) ... I have no idea what, if any, NDT is done ... but I would suspect that the permitted level of porosity would be MUCH lower than what we are seeing in those pictures.....
