ODI RESUME

Investigation: PE09-026
 Date Opened: 05/18/2009 Date Closed: 09/18/2009
 Principal Investigator: Robert Young
 Subject: Motorcycle Front Wheel Separation

Manufacturer: BMW of North America, LLC, Bayerische Motoren Werke
 Products: BMW MY 2000-2003 F650GS
 Population: 4,294

Subject: BMW F650GS Fork Failures

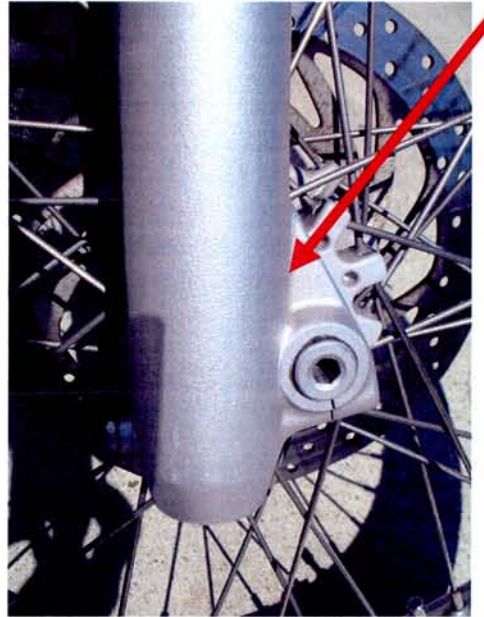
The alleged defective component is the lower fork tube, specifically, the interface between the fork tube and the front axle lug.

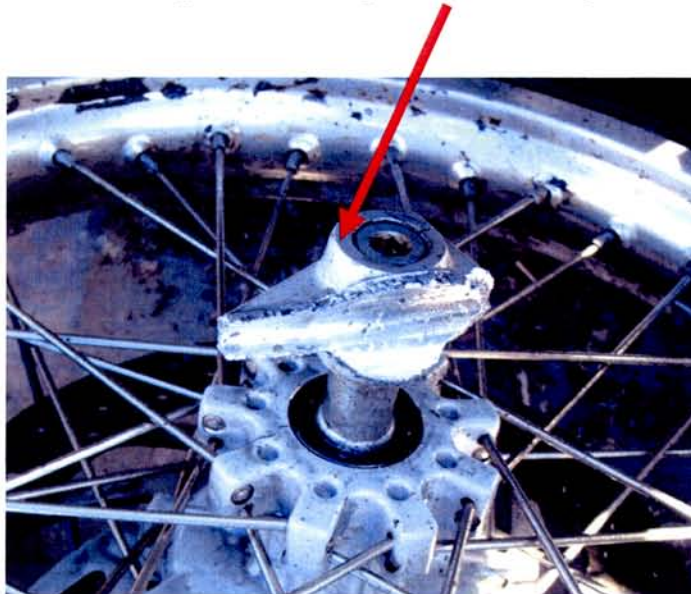
The alleged failure involves a spontaneous separation of the lug from the fork tube.

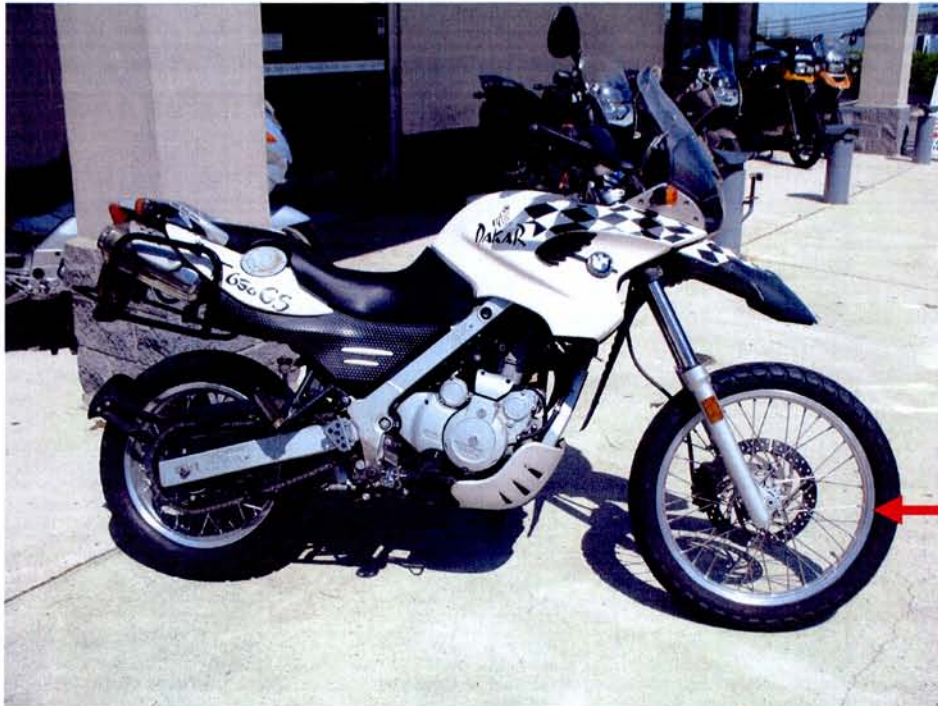
Following each event, metallurgical analyses conducted by BMW, independent analysts, or both, found the fracture occurred due to impact force (a “forced fracture”) rather than fatigue (a weakening of material over time). BMW’s testing found that these fractures would only occur if a force substantially greater than what would be found during normal riding were applied perpendicular to the wheel rim at this point with the fork at full lock.

This later point is important...with the fork at full lock, the assembly cannot rotate around the steering axis and maximum leverage is therefore applied. The type of force needed to break the lug can only be found in crash events (even minor ones) when the fork is bearing against the steering stop. Simply riding over a railroad crossing (as alleged by one ODI complainant), or hitting potholes or rocks while riding normally will not produce the unique combination of force, direction, and geometry needed to separate the lug. It is precisely this unique combination that explains why failures are infrequent. If simply riding over a railroad crossing, for example, would produce this failure, we would expect there to be many, many more failures since rail crossings are so common.

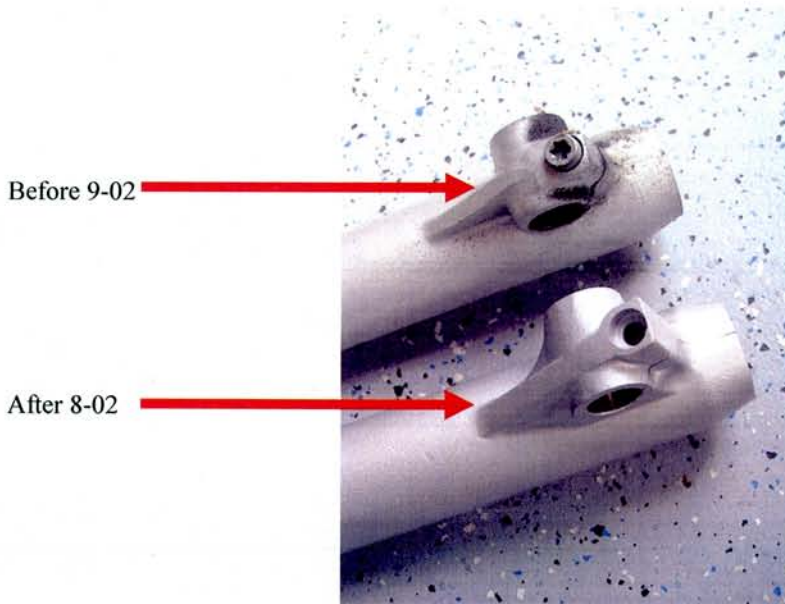
Beginning in September 2002, BMW began producing F650GS's with a reinforced lug/fork interface.

According to BMW, this change was made to ensure that riders were not stranded while riding in remote sections of the world simply because a lug separation occurred as a result of a minor crash.¹ The change has been effective for, while the occurrence frequency was already low with the early design, no lug separations have occurred involving the current design.
