ODI RESUME

Investigation: PE 09-026
Date Opened: 5/18/2009
Principal Investigator: *Bob Young*
Subject: Motorcycle front wheel separation

Manufacturer: Bayerische Motoren Werke (BMW)
Products: BMW 2000-2004 F650GS-Series motorcycles
Population: 6,136 (Estimated)

Problem Description: Full or partial front wheel separation when fork axle lug fails.

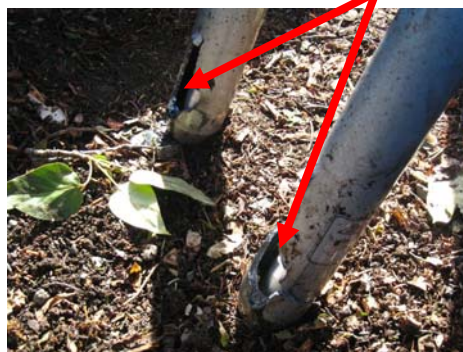
Summary: Between August 15 and December 26, 2008, apparently prompted by a 8-9-08 web forum posting by "redbaroness" (<http://www.advrider.com/forums/showthread.php?t=371650>), ODI has received five vehicle owner questionnaires (including one from "redbaroness") alleging full or partial front wheel separation occurred when the fork's axle retaining lug failed. This photo shows redbaroness' front fork with the missing axle lugs after her crash.
