Metallurgical failure analysis

Re: G68/BMW
D/A July 2003

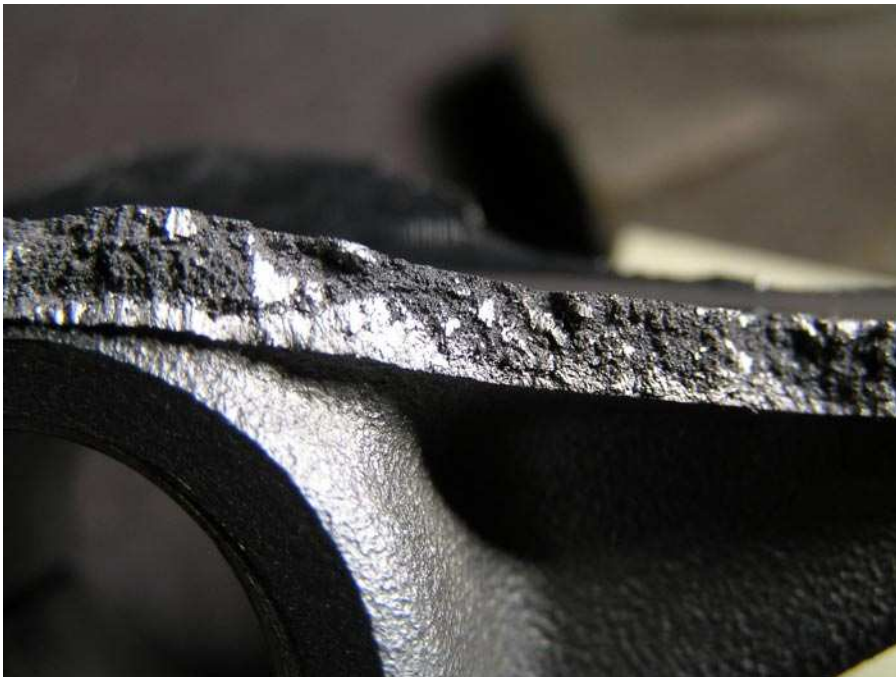
Right fracture (Photo 027)

Based solely on my examination of the subject parts, it is my opinion that a critical portion of the fracture surface exhibits macroscopic evidence demonstrating that this is a fatigue fracture. This would lead to the conclusion that a crack existed in this part prior to the time of the accident.

The photograph of the right fracture shows the classic semicircular progression marks that are the unique characteristic of fatigue fracture, which is the result of a substantial number of repetitive loads, of the order of at least thousands or more. Not only is a relatively large semicircular mark visible, but just to its right are several smaller semicircular progression marks. This portion of the fracture grew as several independent small fatigue fractures ultimately joined with the larger progression mark (fracture). At some point, under ordinary operating conditions, the overall size of the crack grew to critical size and sudden and complete fracture occurred, causing the accident.

From an engineering point of view, this accident appears to be a case of *res ipsa loquitur*, for the failure occurred under normal operating conditions: 35 mph on a straight road, with an experienced rider. Furthermore, the fracture could not have taken place as a consequence of the subsequent fall, because in that case the fracture appearance would have been different. If it didn't occur in the fall, the fracture had to have preceded and been the cause of the fall. Whether the strut was defective because of a deficiency in design or improper manufacture has not yet been established.
