Examination of Fractured Motorcycle Fork Leg

Date: 3/15/09

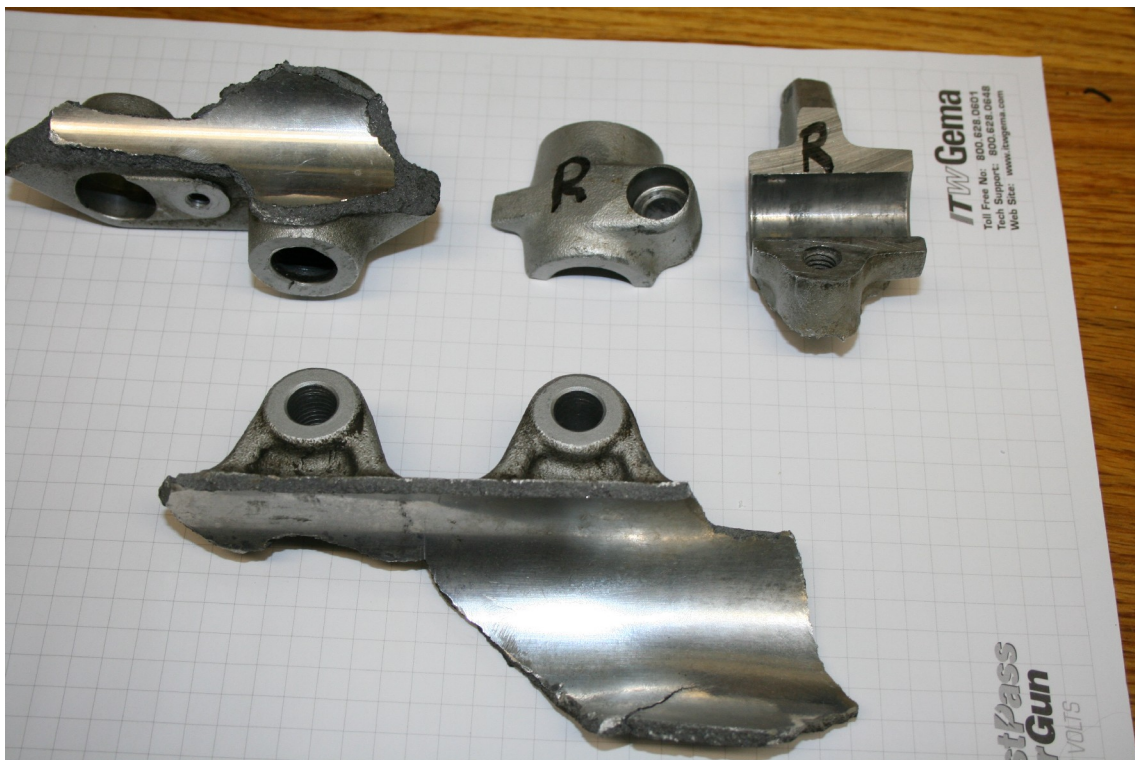
Four pieces in total were received, as shown in Figure 1. The samples had come from both fork legs. Three pieces contained fractures; one did not. The samples were examined with the unaided eye as well as a 10x pocket magnifier and the following characteristics noted:

Fractures did not show any evidence of fatigue initiation or propagation. Fracture mode was entirely due to a one time overload event or sequence of several overload events. Fracture texture suggested that the method of manufacture was sand casting rather than high pressure die casting. The fracture was free of gross casting flaws, such as inclusions, porosity, or cold shuts. The bore of the fork legs exhibited areas of “orange peel” finish, which suggests that the bore surface was finished by a roller burnishing process. The bore was free of microporosity. In several areas adjacent to the fractures, numerous small cracks were noted that were oriented parallel to the major fractures. This condition was present on all fracture pieces. Several dozen of these small

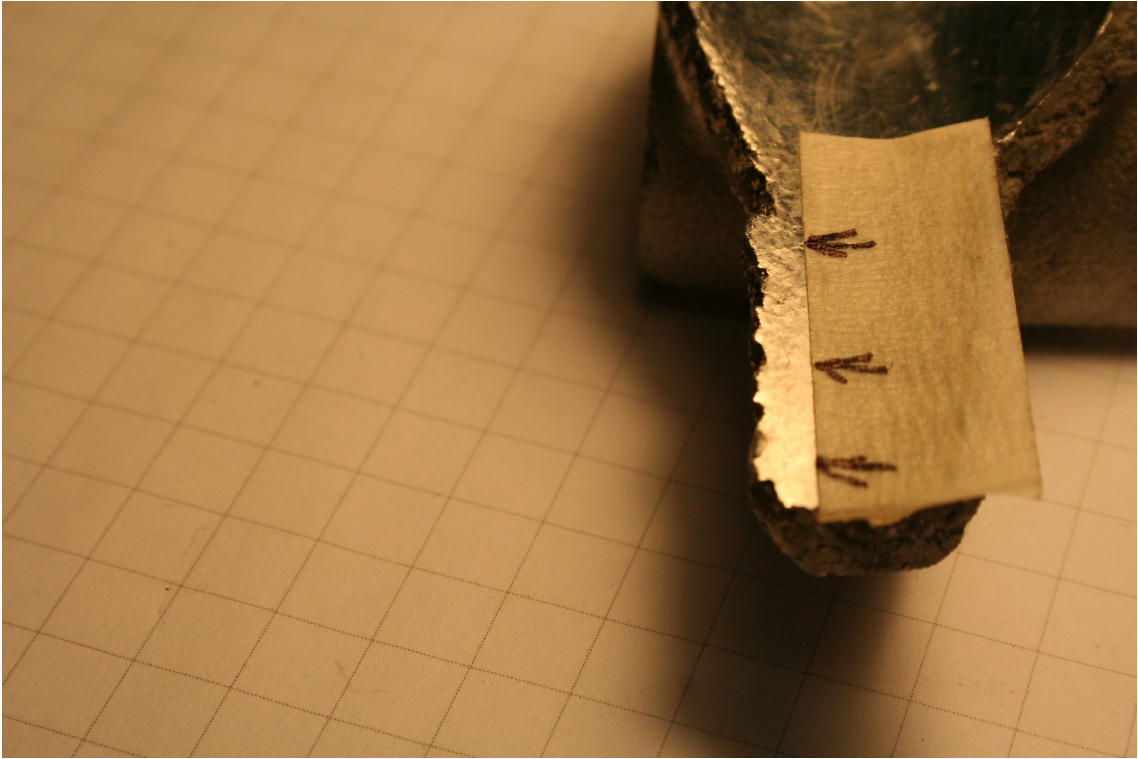
cracks were noted on the three fractured pieces. These small cracks were arrayed into clusters parallel to the main fracture and were several tiers deep, i.e. they were not all in line.

Figure 2 shows (arrows) one area where the crack network was present and the orange peel texture of the bore can also be noted.

The presence of the clusters of small cracks adjacent and parallel to the main fractures suggests that they were present prior to final fracture. Although some small, secondary cracks in the vicinity of the main fracture could be expected with overload fractures of cast aluminum components, the cracks observed were far too numerous to have been a result of the final overload. Instead, they appeared to be some of sort of pre-existing condition. There are several potential sources of such cracks:

- 1) A network of hot tears in the casting.
- 2) Cracking during roller burnishing of the bore.
- 3) Cracking during a thermal deburr process after machining.
- 4) An interdendritic weakness resulting from an over temperature condition during heat treating, i.e. eutectic melting. This condition could have led to cracking during machining or roller burnishing.

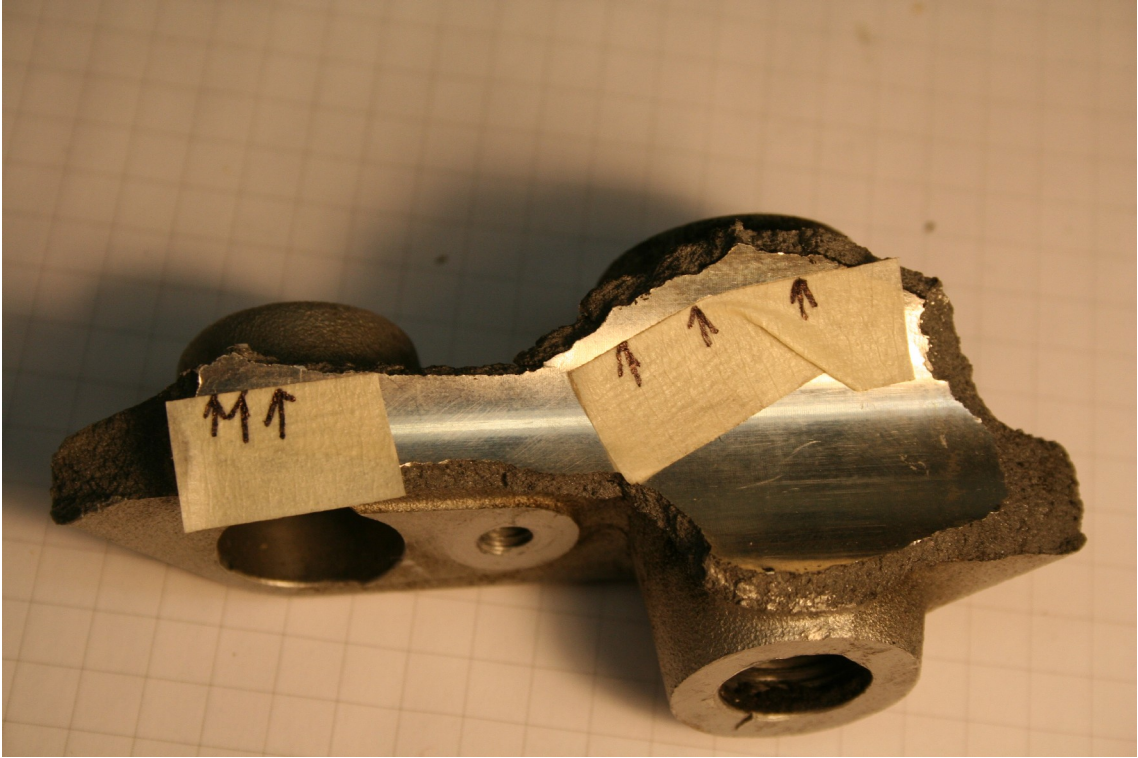
Figure 3 shows another section where these network cracks were present; location has been marked with arrows.
